ARMY RESEARCH LABORATORY

Evaluation of Static Line Webbing Materials Subjected to Simulated Airdrop Operating Conditions

ARL-TR-2713 April 2002

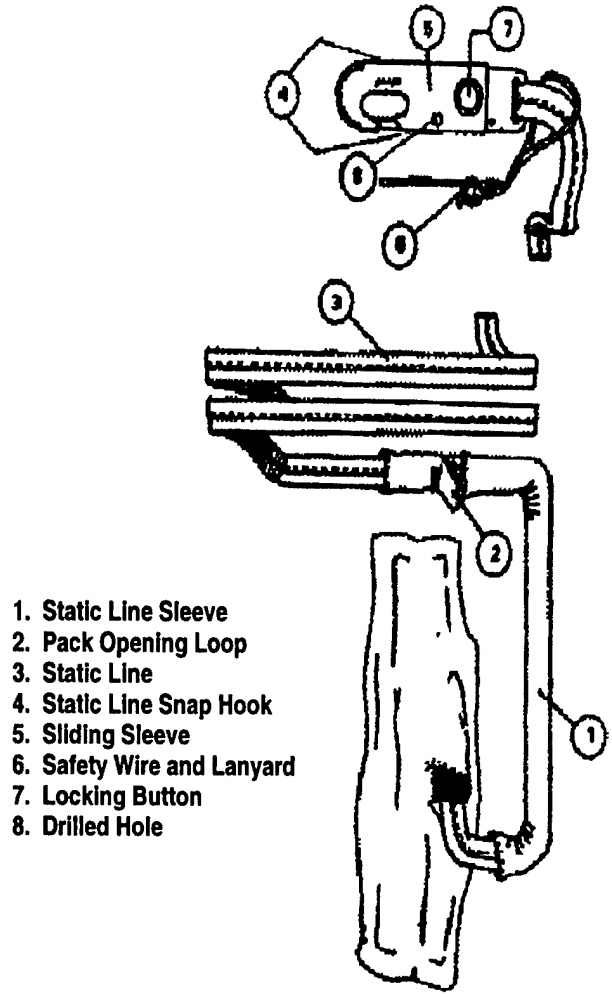
Figure 1. Basic components of the T-VIII static line system [2].

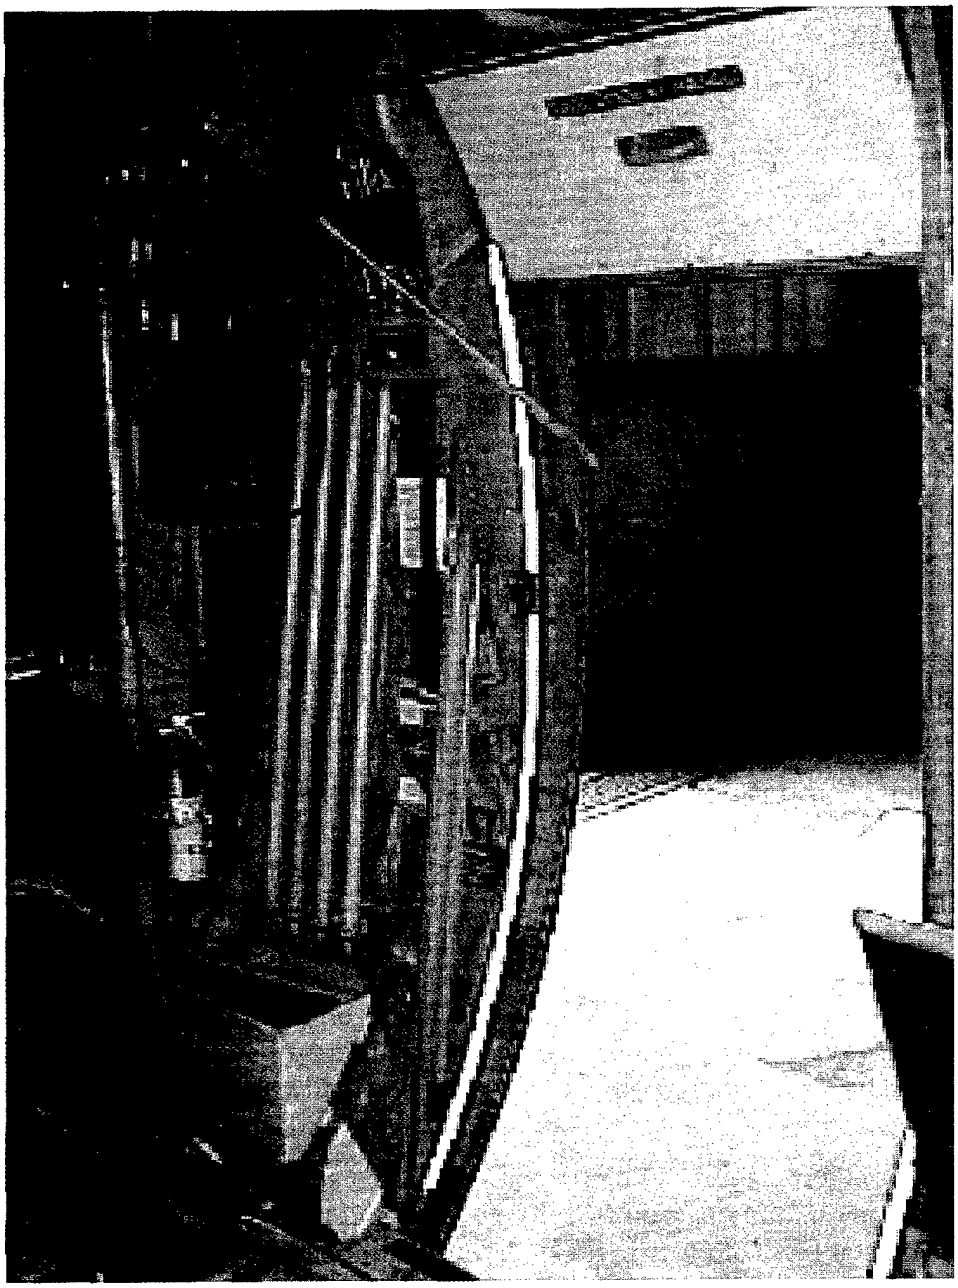
door edge (despite a prejump inspection of the surface and application of tape to minimize imperfections). Many static lines that have ruptured as a result of jumper entanglement with the line have broken at the point where they were in contact with the door edge.

Figure 2. Onboard view of a static line extending out of an aircraft door in the postjump, preparachute deployment configuration.

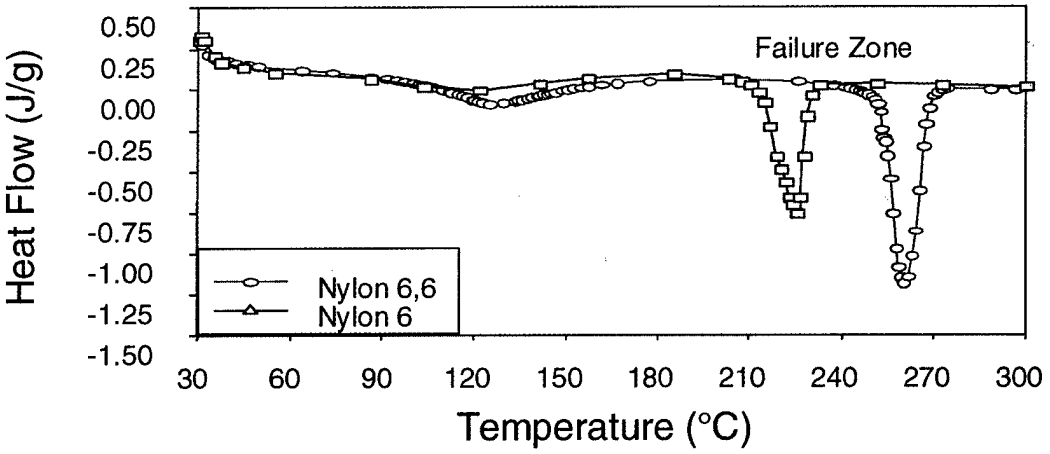
DSC results of failure zone samples taken from the ruptured lines are shown in Figure 3. Plots of heat flow vs. temperature feature the characteristic change in heat flow (depression and recovery) associated with the melting of polymer crystals (T_m) between 210° and 270 °C. The T_g onset of both specimens is ~50 °C (T_g [nylon 6] = 47 °C, T_g [nylon 6,6] = 50 °C) using a 10 °C/min ramp rate. Comparing both T_g and T_m with handbook values allows conclusive determination that the low T_m line is nylon 6 (poly ε-caprolactam), and the other line is nylon 6,6 (poly[hexamethylene adipamide]). These polymer assignments were further confirmed by noting the presence of color-coded tracers stitched into the ruptured cords. For these lines, it was determined that the manufacturer used a black stringer to designate the nylon 6,6 material and a red stringer to denote a nylon 6-based line system. One of each had failed and been examined with experimental results in complete agreement with the manufacturer's color-coding system.

Figure 3. DSC investigation of two field failed nylon jump cords demonstrating the effective use of thermal characterization for discerning compositional differences in the two materials. Assignment of each of the polymer fibers is shown in the legend.

DSC analysis results indicate that both failed lines ruptured for reasons other than those related to material property degradation. No apparent (DSC detectable) change in the base material properties occurred as a consequence of field use. It would appear, therefore, that the static line failures either occurred as a result of mechanical overload or due to progressive and excessive tearing. This assumes that the unused factory material, used as a standard to contrast the quality of the used lines, is suitable in terms of strength and ductility for static line applications and functions as a reasonable baseline comparison. Results of thermal investigations of factory materials indicate that this should be a valid assumption.

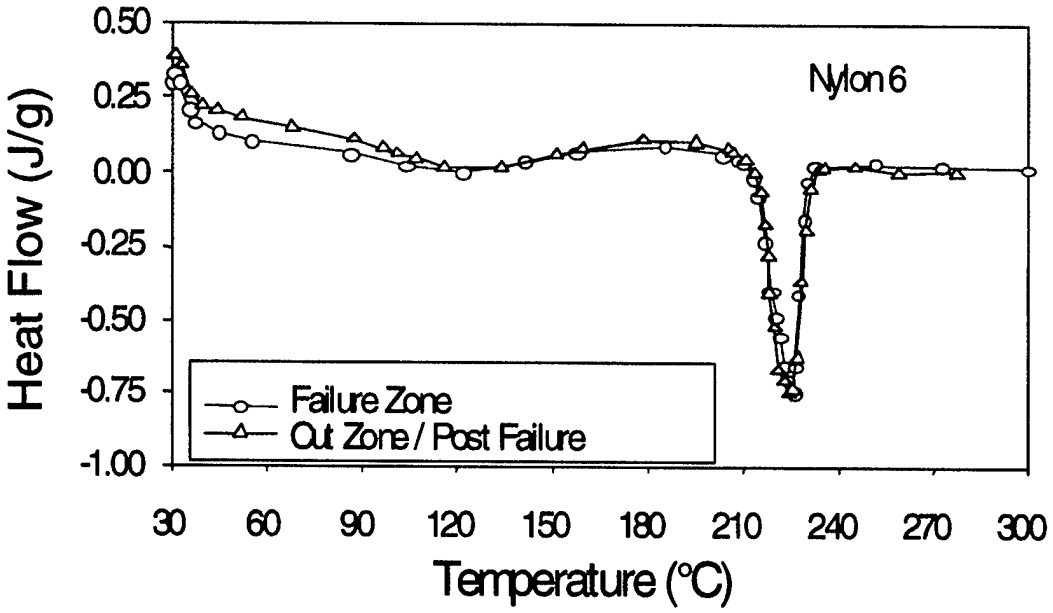
DSC results of bulk (cut zone) and failure zone samples taken from the nylon 6 line are shown in Figure 4 with a reduced temperature range for the crystalline melting transition T_m shown in Figure 5. Comparing the experimental result shows that no significant differences are present between either the melting or glass transition temperatures of the two samples. The slight variations in melting temperature indicate that a small variation in the crystallite content or crystal domain size is possible. However, these small inconsistencies are not significant (3–5%) and are typically the result of accumulated errors from the sample size, sampling technique, and instrumental error. For instance, sheared surfaces generated during sample extraction with scissors, selection of fibers for sampling, and packing of fibers in the sample pan all contribute to thermal transfer differences between the polymers and the instrument which can result in as much as 5% sample variation. The variations observed in Figures 4 and 5 are common among samples from a same-source with known loading histories.

Figure 4. DSC trace of nylon 6 from room temperature through the crystalline melting point of nylon ropes. Agreement between results measured in and far from the failure zone for a single rope is excellent.

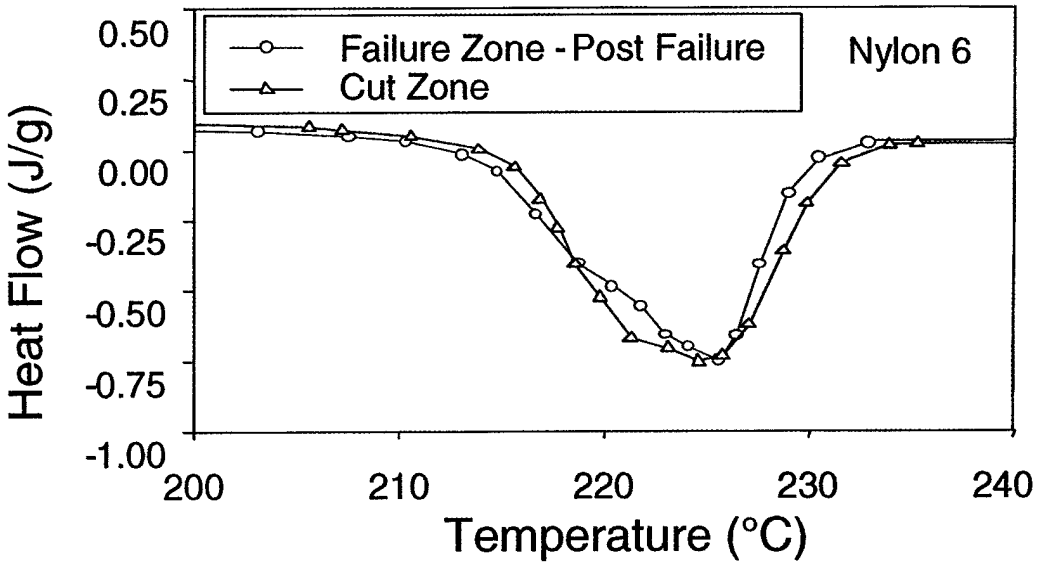
Figure 5. Crystalline melting traces of fielded nylon 6 jump cords determined using DSC. Fielded samples show no substantive variations between bulk matrix fibers attained far from the failure zone and fibers extracted from the failure zone.

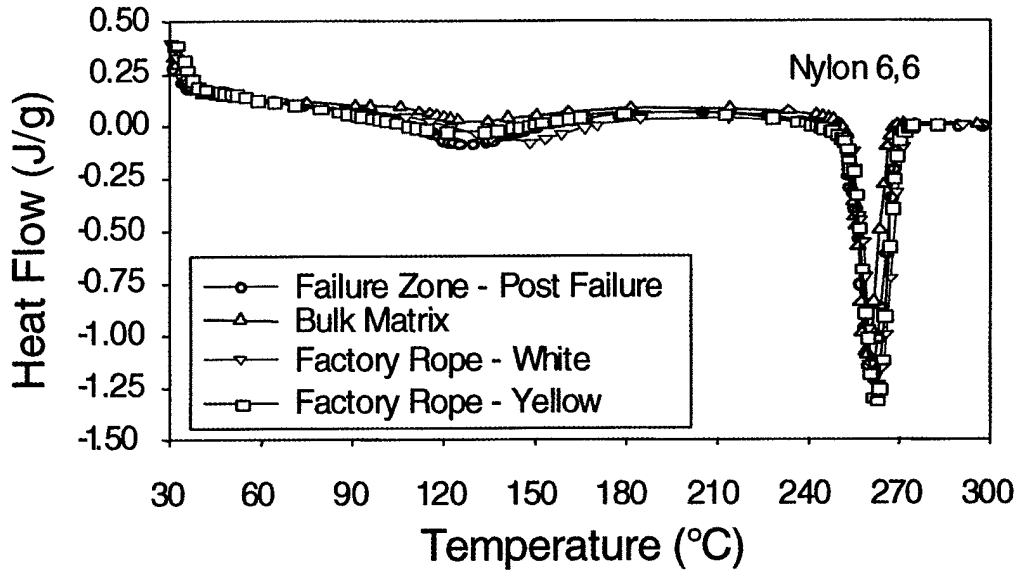
Results of the DSC test performed on the nylon 6,6 line are shown in Figure 6. This figure reports results of failure and bulk zone samples, as well as results obtained from unused factory specimens. The unused samples were determined to be nylon 6,6 via independent DSC testing and are included to demonstrate the insignificant differences between the signature characteristics (DSC plots) of the unused vs. used material samples. Figure 7 is an enlargement of the T_m zone of for nylon 6,6 sample. Note that the DSC analysis did detect a slight difference

Figure 6. DSC trace of nylon 6,6 from room temperature through the crystalline melting point of nylon ropes. Agreement between various samples is excellent.

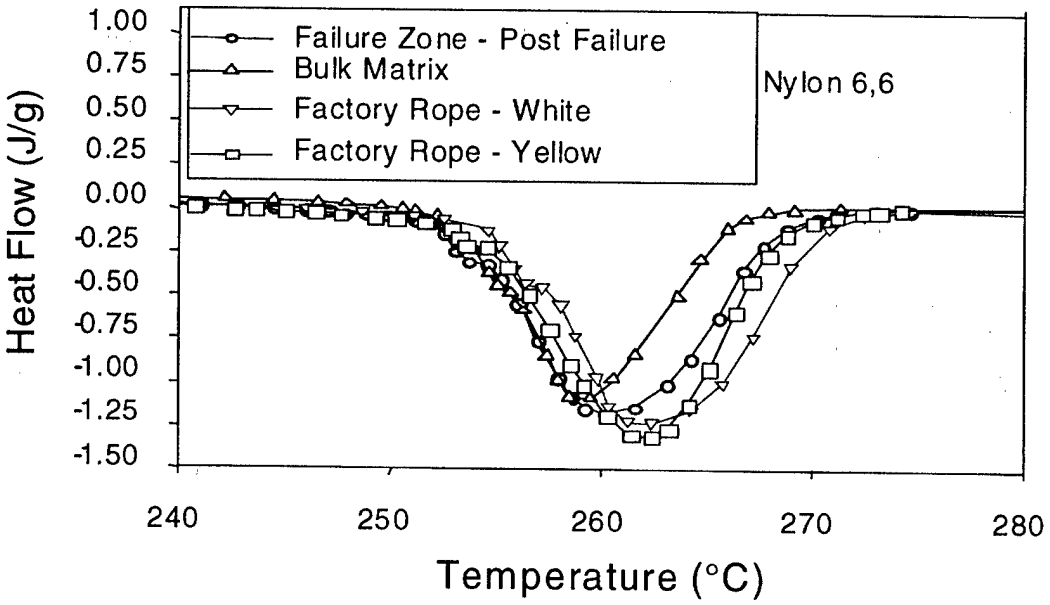
Figure 7. Crystalline melting region for nylon 6,6-based jump cords showing minimal deviations in crystalline structures for factory original vs. field failed cords.

between the white vs. unused yellow nylons. This difference, potentially arising from the coloring process or additives, is again comparable to the difference between bulk and failed fiber samples and is still within the experimental error margin of the measurements. Given that the fielded static lines are colored, any variations between the fielded lines and the non-dyed factory sample (Factory Rope—White) were disregarded. A summary of DSC test result data for both nylon types is shown in Table 1.

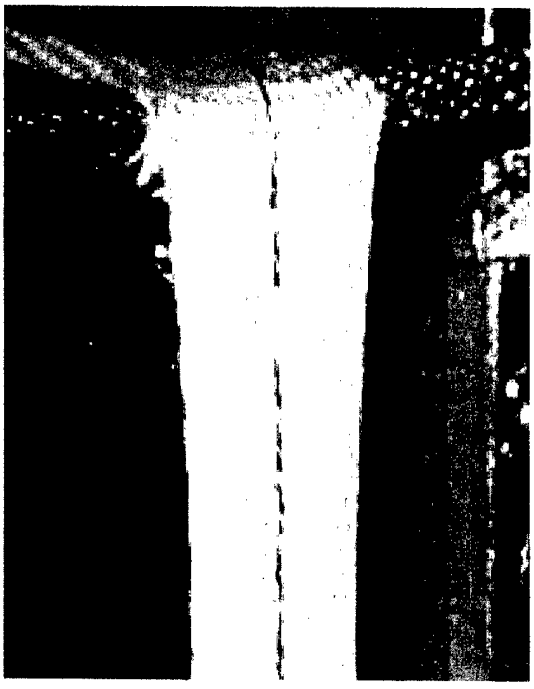
The crisp failure features of the load-displacement curves attained with the T-VIII material using rough bend plates are likely due to catastrophic failures initiated by excessive tearing damage imparted by the surface of the knurled bend plate. In these test cases, it is likely that the rough surface of the bend plate evenly retarded translation of the lower web of the specimen and prevented shear transfer of tensile loads. In this configuration, a failure would be catastrophic as is shown by the sharp clean failures plotted on the rough bend load-displacement curves (with 0.500-in rough bend being the single exception).

Figure 27. T-VIII specimen with 0.375-in-diameter rough bend plate. The absence of the transverse stitching is shown below the bend plate.

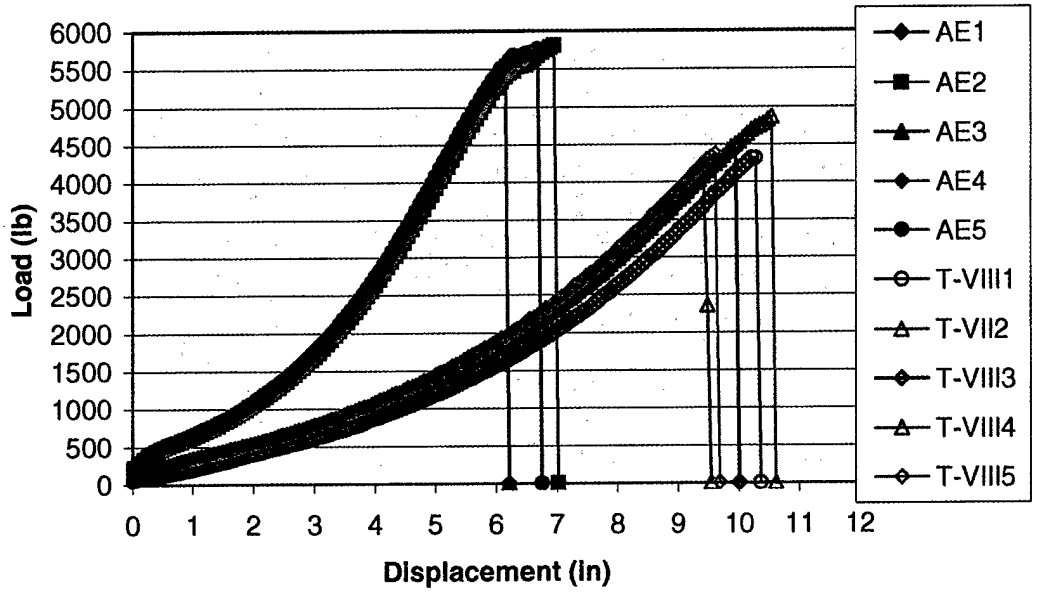
Figure 28 details the characteristics of the pre-failure load-displacement behavior of both static line types tested in the straight-pull configuration. The full array of non-sheathed bend-pull configurations, with both smooth and rough bend plates and with all three bend diameters are shown in Figures 29–34.

Figure 28. Load-displacement curves generated for T-VIII and AbsorbEdge specimens in the straight-pull configuration.

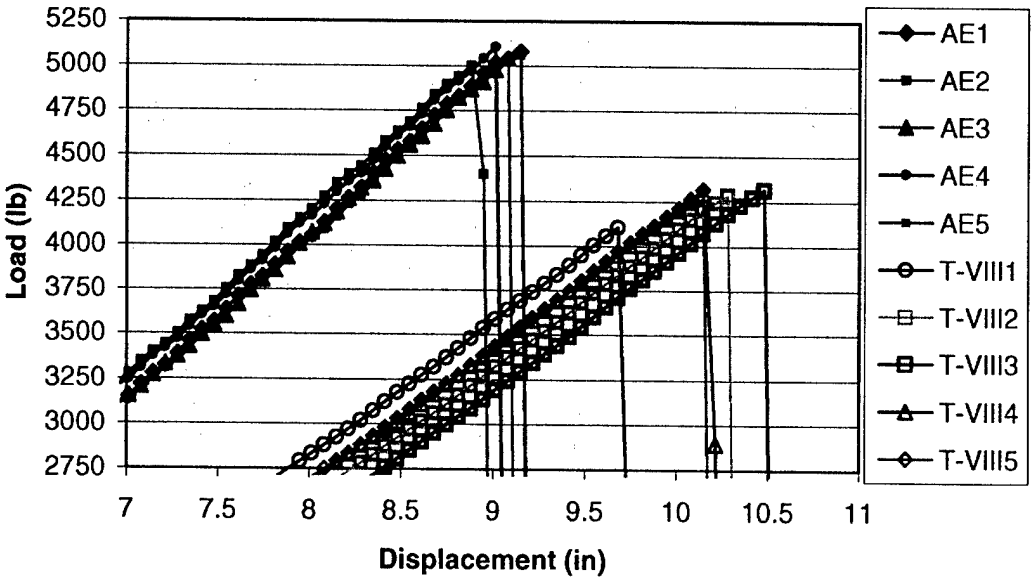
Figure 29. Failure region of the load-displacement curve for both materials using 0.500-in-diameter smooth bend plate.

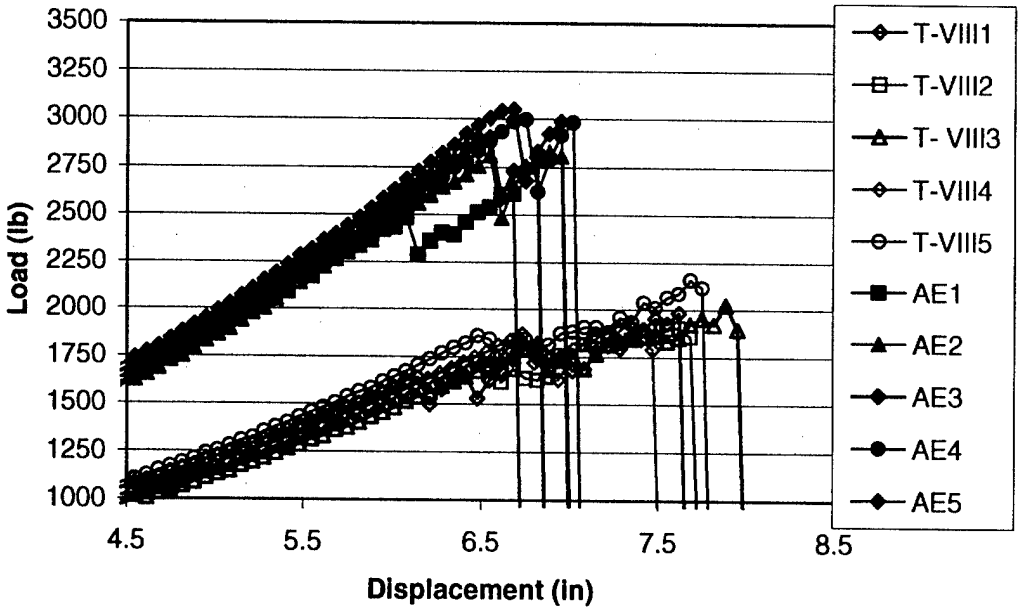
Figure 30. Failure region of the load-displacement curve for both materials using 0.500-in-diameter rough bend plate.

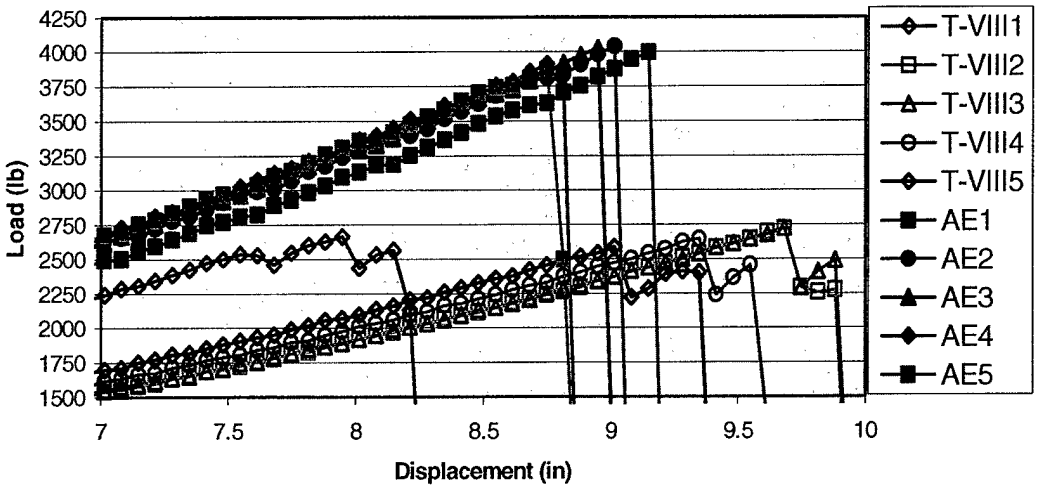
Figure 31. Failure region of the load-displacement curve for both materials using 0.375-in-diameter smooth bend plate.

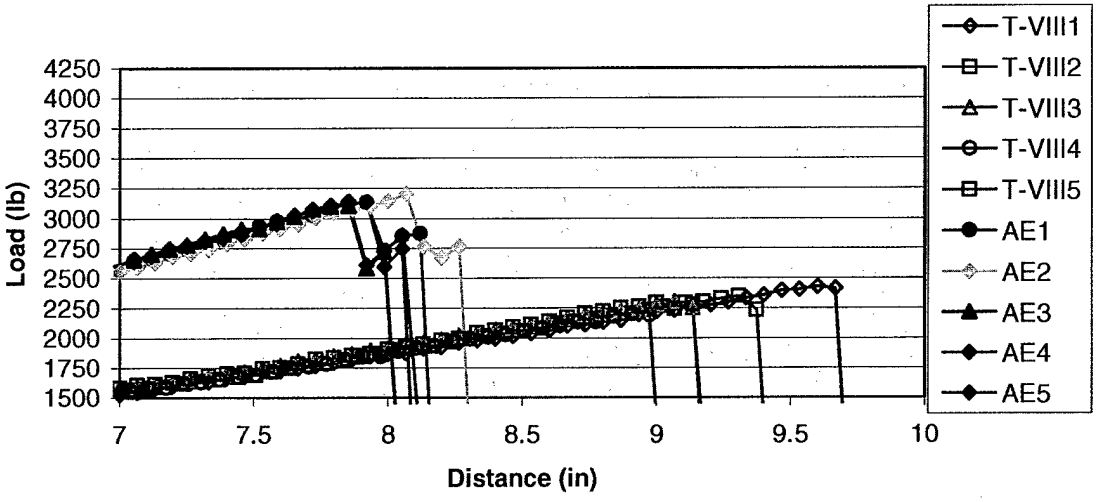
Figure 32. Failure region of the load-displacement curve for both materials using 0.370-in-diameter rough bend plate.

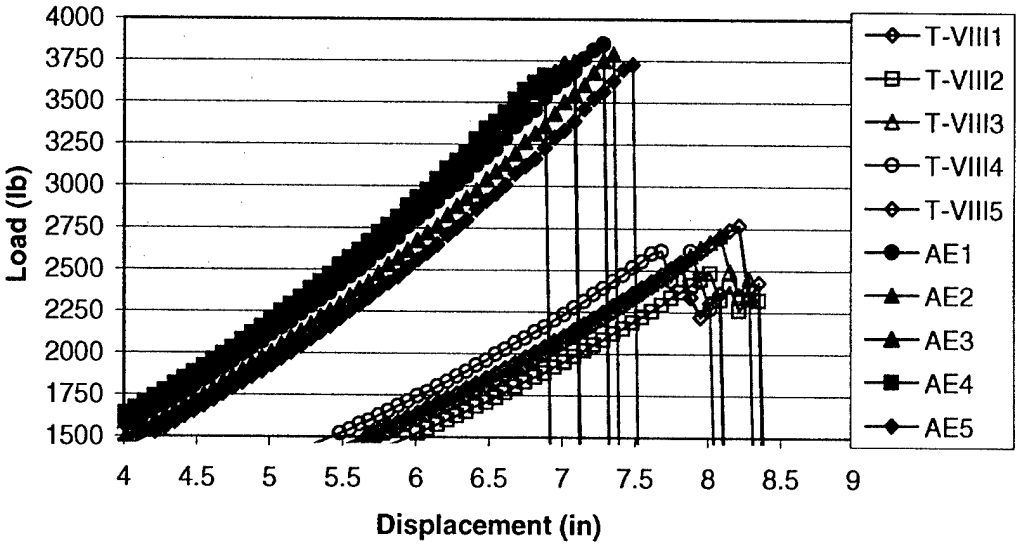
Figure 33. Failure region of the load-displacement curve for both materials using 0.250-in-diameter smooth bend plate.

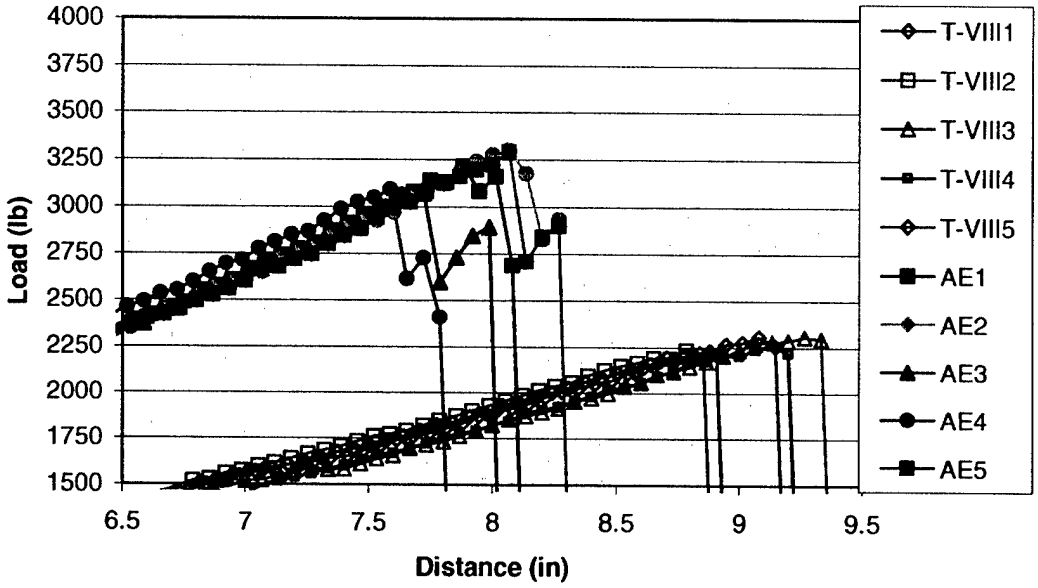
Figure 34. Failure region of the load-displacement curve for both materials using 0.250-in-diameter rough bend plate.

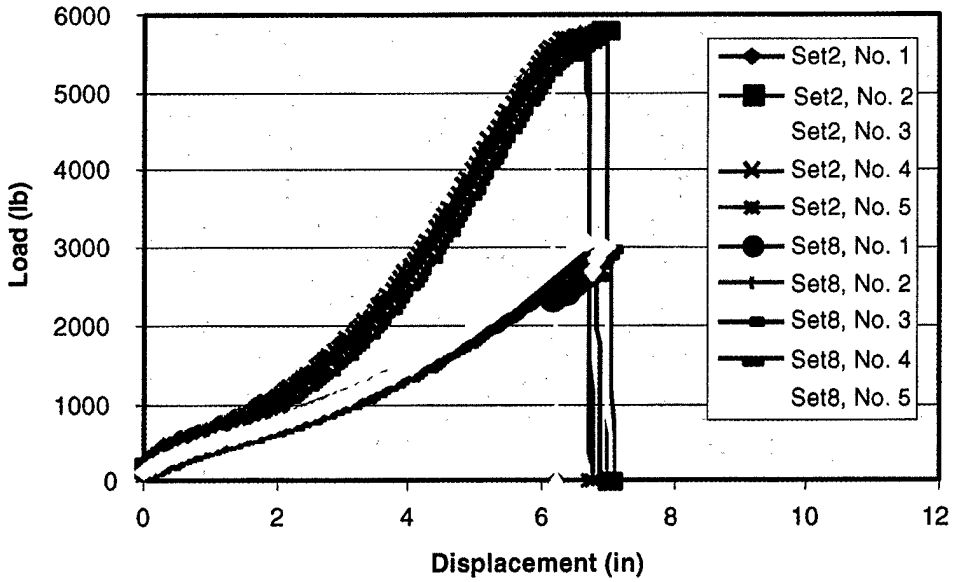
Figure 35 shows the AbsorbEdge load vs. displacement curves generated during test set 2 (straight-pull) and test set 8 (0.500-in rough bend). Notice that the average spring constant (the average slope of the curves) for the straight-pull tests is significantly higher than the spring constant obtained from the bend test curves. The displacement to failure, however, is about the same for the

Figure 35. Load-displacement traces of straight vs. rough 0.50-in bend pull for AbsorbEdge.

AbsorbEdge material in the straight-pull and bend configurations. The active gage length of the specimen is considerably longer in the bend test configuration explaining some of the change in the effective stiffness (as loading is achieved by the displacement of the test machine crosshead). The change in load distribution, due to the bearing of the material around the bend plate contributes to the change (reduction) in rupture strength as compared to the straight-pull tests.

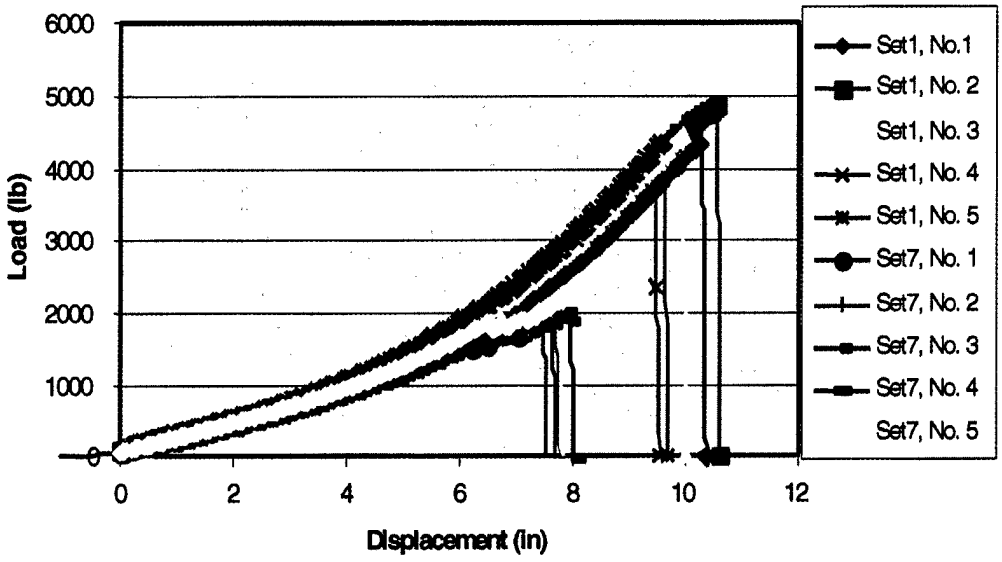
Figure 36. Load-displacement traces of straight vs. rough 0.50-in rough pull for T-VIII.

Figure 36 shows the curves generated for the T-VIII material (test set 1—straight-pull and set 7—0.500-in rough bend) shown in a format similar to Figure 35. For the T-VIII curve sets, the two spring constants (straight and rough bend) are indistinguishable up to the onset of bend specimen failure. The lower stiffness due to the extended gage length observed with the AbsorbEdge bend specimens is not apparent with the T-VIII. Additionally, a reduction in displacement to failure occurs with the T-VIII between the straight-pull and bend-pull tests unlike the response seen in the AbsorbEdge comparison.

Additionally, the T-VIII bend specimens exhibits a region of about 2 in of displacement (between the 6- and 8-in ticks along the abscissa of Figure 36) where the specimens from test set 7 appears to soften prior to failure. Transversely oriented fibers drawn over the abrasive surface of the knurled plates are probably damaged (and eliminated from transferring any portion of a shear load), which results in a lengthening of the specimen or gage length. Since the loads are applied by displacement of the crosshead of the test machine, an instantaneous lengthening of a gage length results in a load drop as shown for all test set 7 specimens.

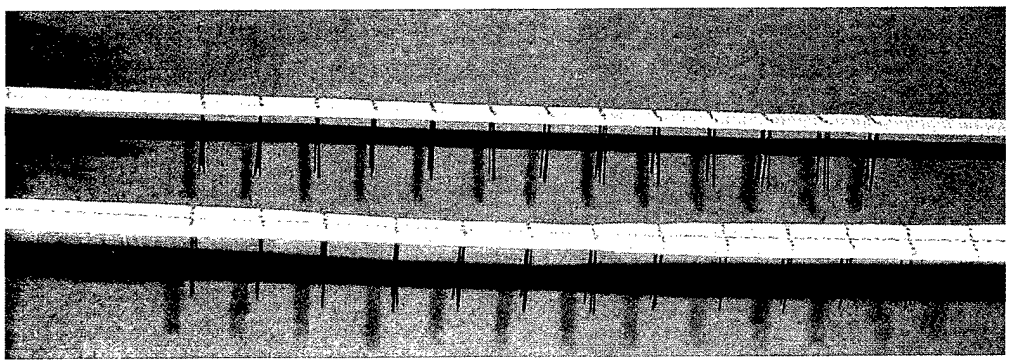
Figure 37 shows both the T-VIII (lower specimen [b] and the AbsorbEdge (upper specimen [a]) static lines prepared with the series of pins arranged in parallel rows spaced 1 in apart (along the green pen marks).

Figure 37. Unloaded specimens prepared with rows of perpendicularly oriented pins.

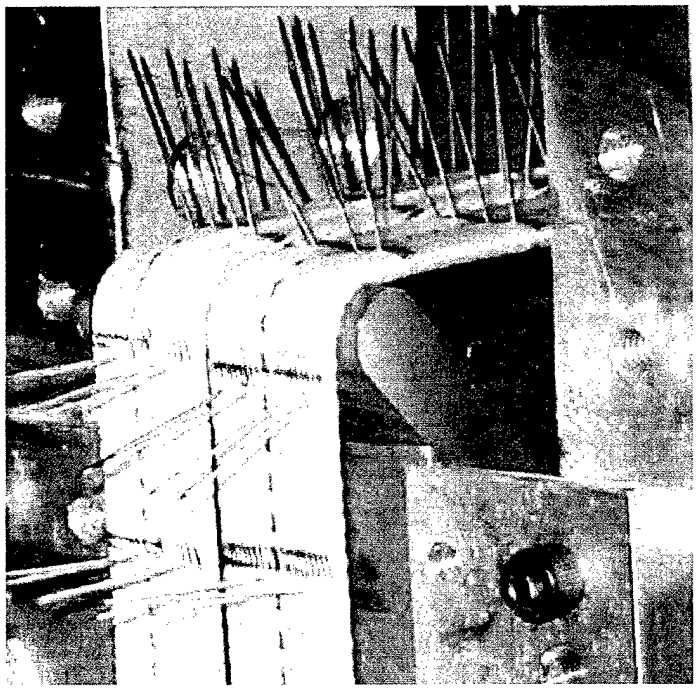
Figure 38 shows both specimens (T-VIII on the left [a] and AbsorbEdge on the right [b]) loaded side by side in the bend fixture using a 0.500-in smooth bend plate subjected to a shared load of ~185 lb.

The pins shown in Figure 38 were virtually perpendicular to the upper web surface of the test specimens subject to a preload of ~185 lb. As loading progressed, the rows of pins advanced toward the bend plate and began to

Figure 38. Bend fixture with a 0.500-in smooth bend plate, (a) T-VIII and (b) AbsorbEdge.

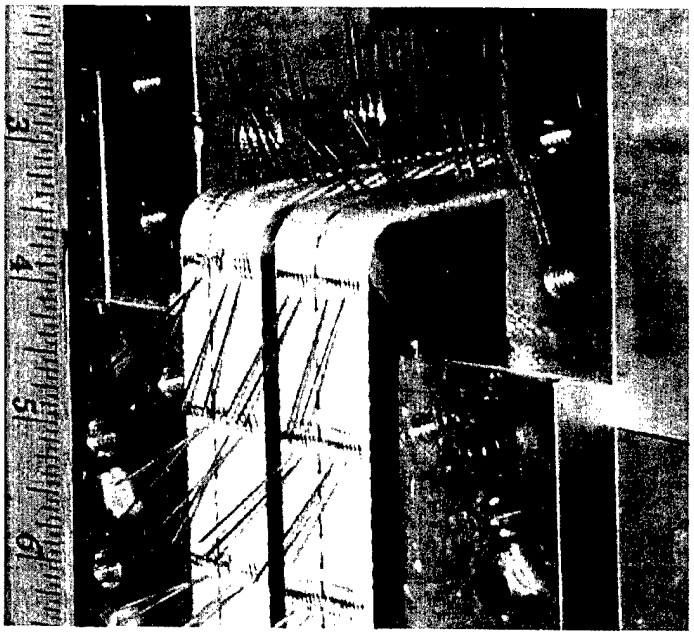
incline forward as shown in Figure 39 (~2100 lb). The orientation of inclined pins is indicative of the upper web straining (translating) at a greater rate than the lower web and proves the difference in their relative motions.

Figure 39. Bend fixture with a 0.500-in-diameter smooth bend plate loaded to ~ 2100 lb, (a) T-VIII and (b) AbsorbEdge.

Of equal significance is the orientation of the inclined pins after (below) the bend plate. Figure 39 shows three rows of inclined pins after having been pulled over the bend plate. All of these pins exhibit the advanced upper web orientation. The only noticeable difference is that the T-VIII specimen shows the second pin from the left (positioned through all three layers) at a lesser incline than adjacent pins for each of the rows shown (pre- and postbend plate). This behavior indicates the difference in translation rates across the width of the T-VIII line. The AbsorbEdge line shows a more consistent pattern of even inclines across the width of the specimen for each of the pin rows.

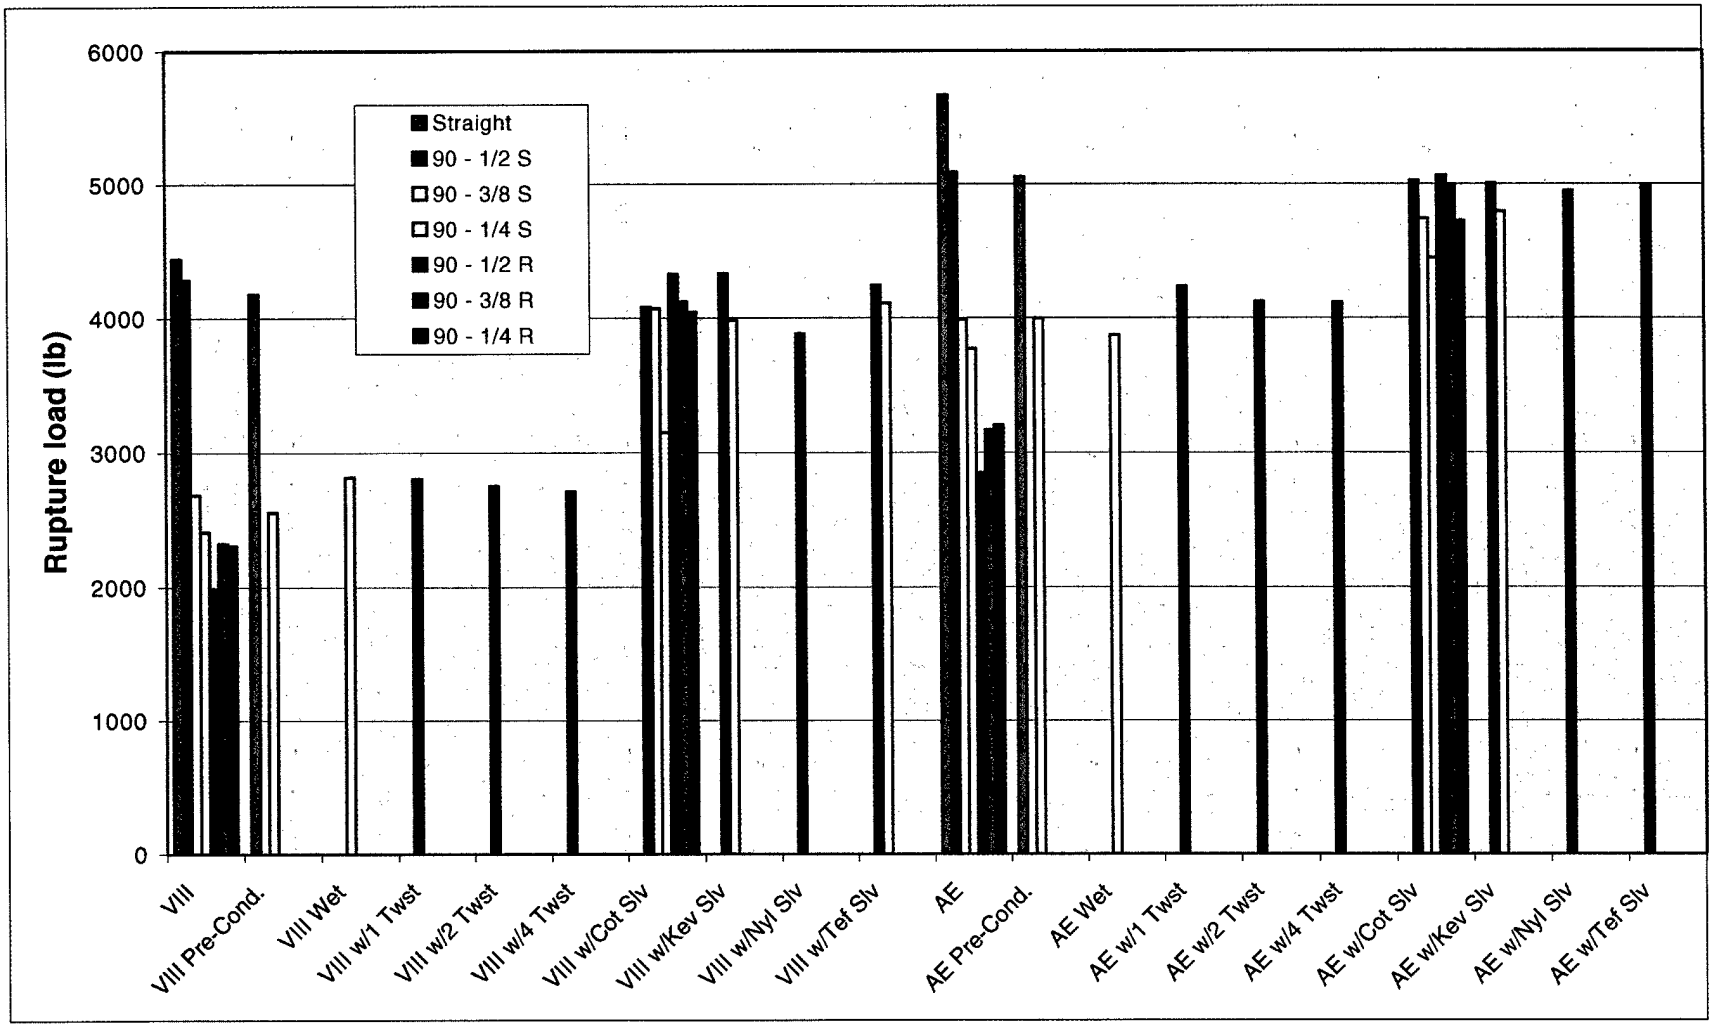
Data collected from the various tensile tests performed during this investigation clearly demonstrate that the AbsorbEdge webbing material outperforms the standard T-VIII for all types of straight and bend plate rupture tests. A summary of these results is presented in Table 8 and Figure 41. Table 8 summarizes the percent improvement in rupture strength AbsorbEdge webbing material offers over the standard T-VIII. For convenience, the general test parameters are presented in various columns with the percent calculation (AbsorbEdge relative to T-VIII) shown in the last column. A graphical summary of the raw strength data for all of the test conditions reported herein is shown in Figure 41. For the straight-pull tests, the AbsorbEdge webbing demonstrated a 27.6% increase in strength over the standard T-VIII webbing structure.

Figure 41. Average specimen strength for various test conditions for both AbsorbEdge and T-VIII nylon webbing.

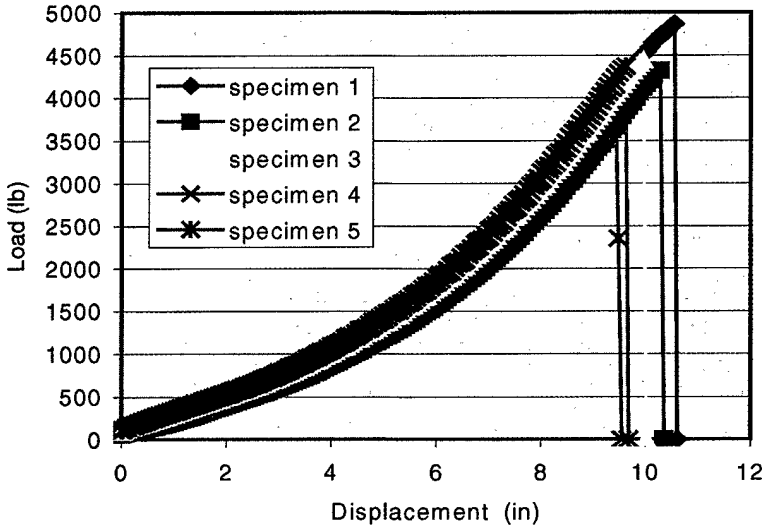
Sample load vs. displacement curves generated during tensile tests are shown in Figure B-1. This figure displays the individual load vs. displacement curves for the five specimens of test set 1 Type VIII (T-VIII), straight-pull configuration). Table B-1 shows the contents of the corresponding statistics report generated by the Instron Series IX software used to acquire test data and process results. Reports similar to Table B-1 were used to generate the tables in the main report.

Figure B-1. Load vs. displacement curves for test set 1 of T-VIII webbing.
